GEOTECHNICAL INVESTIGATION OF A LANDSLIDE INCIDENT IN HULU KELANG, MALAYSIA

Jestin Jelani¹, Muhammad Shafiq Soffian Abdul Rahman¹, Suriyadi Sojipto¹, Wan Mohamed Syafuan Wan
Mohamed Sabri¹, Lee Min Lee² and Nordila Ahmad¹

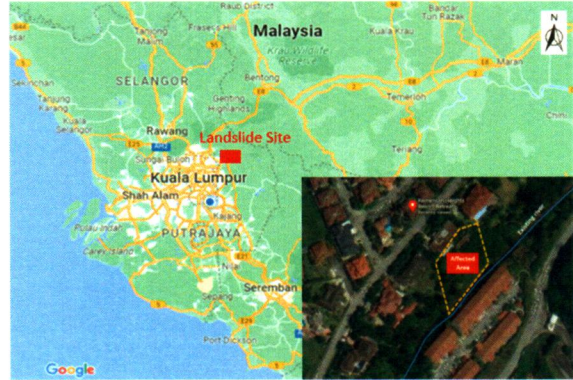
Fig. 1 shows the photograph taken at the studied landslide. The landslide translated approximately 2536m² of earth, blocking a river downstream of the slope (Fig. 2). It affected three bungalows and 19 double-story houses at the top and toe of the slope and necessitated the evacuation of 28 families. However, there was no fatality. The landslide disaster occurred after three days of rainfall. The daily rainfall data at the Bukit Antarabangsa station in Fig. 3 showed the antecedent rainfall from 15, 17 and 18 September 2021 was 23mm/hr, 18mm/hr and 19.2 mm/hr, and 14 mm/hr and 9mm/hr on 19 and 20 September 2021. According to the local experts, the rainfall raised the groundwater table to 3 to 4m from the ground level.

Fig.1 Location of the landslide

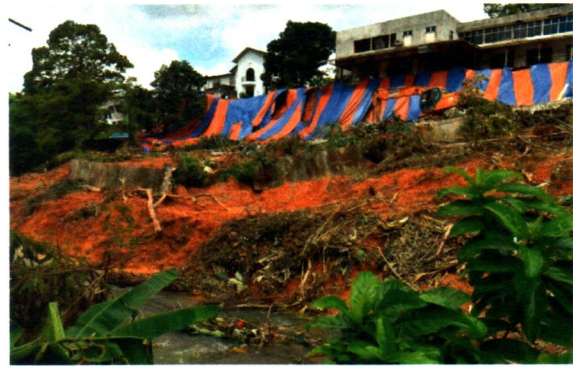
Fig.2 A photo of the affected area taken two days after the landslide.

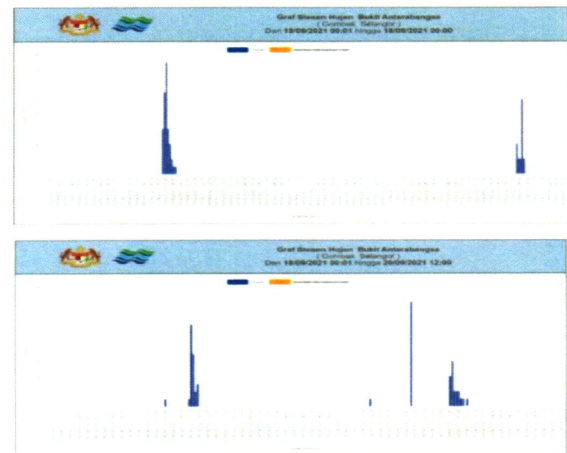
Fig.3 The antecedent rainfall at the Bukit Antarabangsa station.

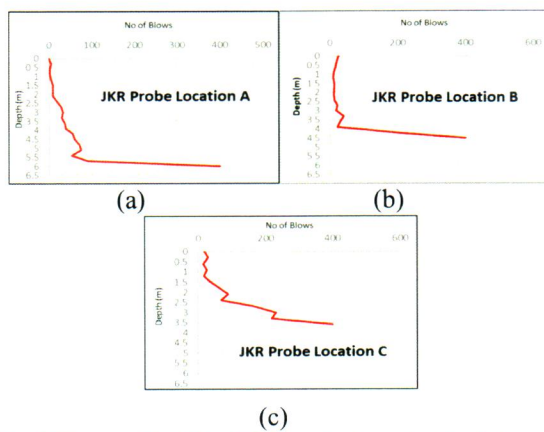
Figure 7 presents the results of the JKR probe test at the top, the middle and the toe of the slope. It shows that the schematic cross-section of the slope can be interpreted with probable hard layer located at depth of 3.5 m to 6 m from the failure plane, as shown in Figure 8. There are distinct soft and hard layers on the slope profile. The hard layer could be a hard rock or dense layer since the JKR probe test penetrated 0.3 m with 400 blows. The soft layer is at a shallow depth 3 to 5 m from the failure surface.

Fig.7 The result of the JKR probe test for the (a) top, (b) middle, and (c) toe of the slope.

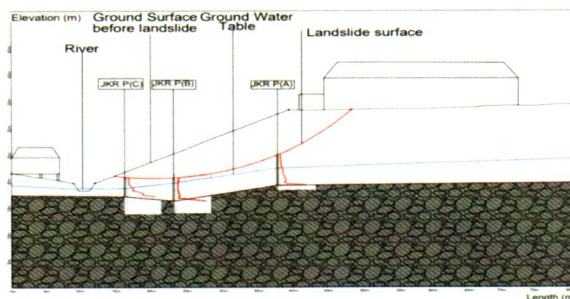
Fig.8 Schematic drawing of the Kemensah Heights slope.

The in-situ test (the JKR probe test) to determine the soil strength showed that the slope consists of distinct soft and hard layers. The soft soil layer was located at a shallow depth of 3.5 to 6 m from the failure plane. The soft layer of the soil could have triggered the landslide since the failure plane did not intersect the hard layer. The laboratory test result showed that the soil at the site was silty SAND (with low plasticity), which consists primarily of 42 % sand and 28% silt. It has a low shear strength with an 11.3 kN/m² cohesion value and a 29° angle of friction, and its unit weight and particle density were 16.51 kg/m³ and 2.63 Mg/m³, and the average permeability was 5.96x10⁻³ mm/s. The soil friction angle was lower than the slope angle. The characteristics of residual soil indicated that it was prone to landslides due to the highly varying engineering properties influenced by

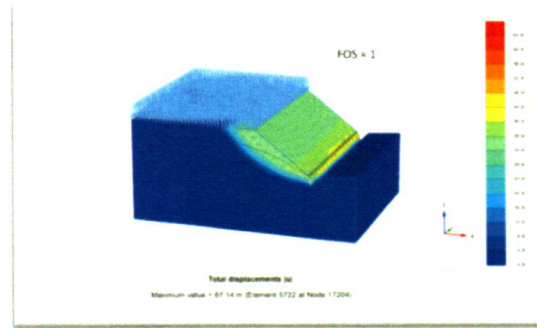
Figure 13 shows the Plaxis 3D results which gave a FOS of 1, indicating that the slope is unstable. The critical slip plane occurred at the crest and intersected at the toe of the slope. The failure line is categorized as a toe failure. The result was validated using SLOPE/W to verify the FOS value. Fig. 14 shows that the FOS given by Slope/W was 1.095, indicating an unstable slope.

Fig.13 The Plaxis 3D result

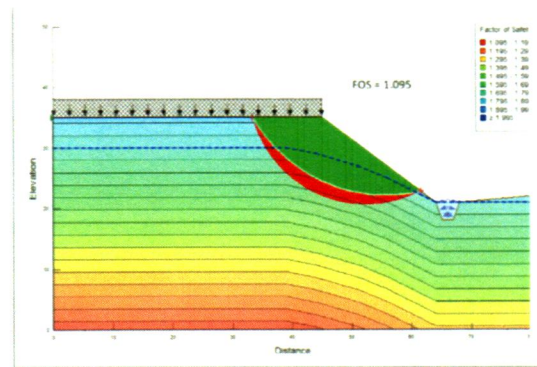
Fig.14 The Slope/W result
