## A Modelling of 500 Kv Long Transmission Line and Fault Detection Using Inverse Definite Minimum Time Over Current (IDMT O/C) relay

*As electricity demand increases day by day due to economic growth, the process of transmitting efficient electrical power is vital. Thus, a power simulation study is required to determine the mechanism of the transmission line, and possible faults that occurred in the transmission line system. On a daily basis, single line to ground fault (L-G), double line to ground fault (2L-G), and triple line to ground fault (3L-G) are the faults that normally occur in the long transmission line system. In this project, a model of a 300km 500 kV EHV transmission line consisting of a three-phase source, distribution line, and load is simulated using MATLAB software. When the L – G fault is applied, the voltage is diminished to zero and upon fault clearance, the R – G line produced overvoltage and overcurrent by 518.9 kV and 1889 A, which increased about 46.83% and 15.67% compared to normal lines of Y – G and B – G at 353. kV and 1633 A. Then, for the 2L – G fault, again the voltage is reduced to zero and when fault clearance occurred, the R – G and Y – G lines e

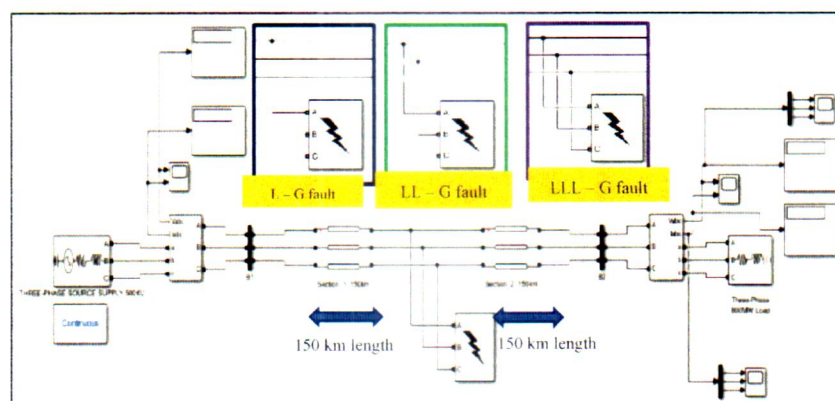
The fault will be located at the mid-point EHV transmission line as shown in Figure 2. Three types of faults will be studying in this project namely single line to ground fault

FIGURE 2. Model 500 kV/300 km EHV Long Distance Transmission Line with Fault Application in Simulink.

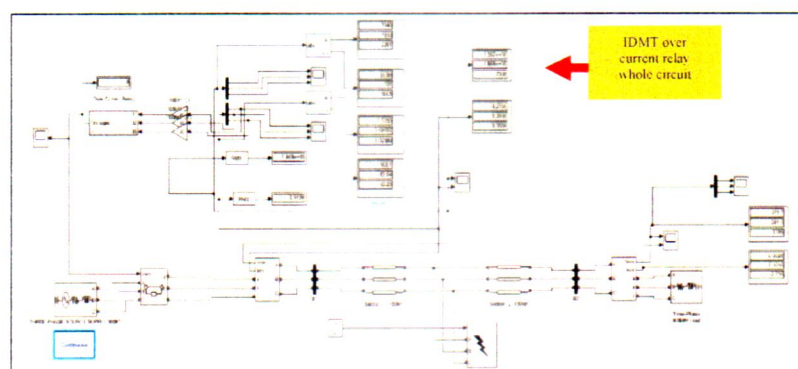
sensitivity to reduce the fault impact along the transmission line. At this stage, an IDMT O/C relay will be used and connected to the circuit breaker. Figure 3 shows a successful connection between IDMT overcurrent relay protection on the transmission line together with the fault, where IDMT O/C works as a protection relay for the lines.

FIGURE 3. Model 500 kV/300 km EHV Long Distance Transmission Line with the application of Fault and IDMT Overcurrent Relay Protection

The IDMT O/C relay will send the signal to the circuit breaker to trip the system if the system is experiencing an overcurrent. The transmission line protection will close, and it will show "1" to notify the overcurrent relay protection is not active since there is no overcurrent triggered the relay protection. The fault applied at 0.1 s causes the circuit breaker to open, then the IDMT will detect the current when it exceeds the current limit in the relay subsystem (Saldarriaga-Zuluaga et al. 2021).

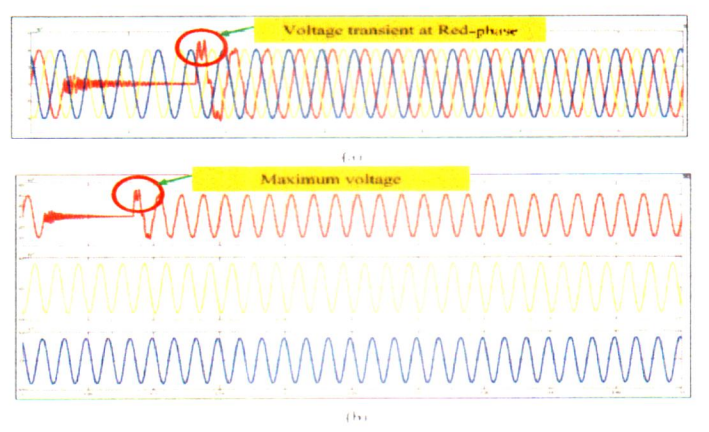
Voltage on faulty stage of R-G lines is diminished and decreased to zero as shown in Figure 6. The voltage of defective stage moreover shoots at the time of clearance of fault at 518.9 kV ( $t = 0.089$  s) compared to Y – G and B – G at 353.4 kV where both lines were operated at normal condition as presented in Table 3. Due to fault, an overcurrent had occurred at R – G lines at 15.67% compared to Y – G and B – G lines at the time of clearance of the fault as shown in Table 4 and Figure 7. The waveform

FIGURE 6. (a) Output voltage (b) R – Y – B output

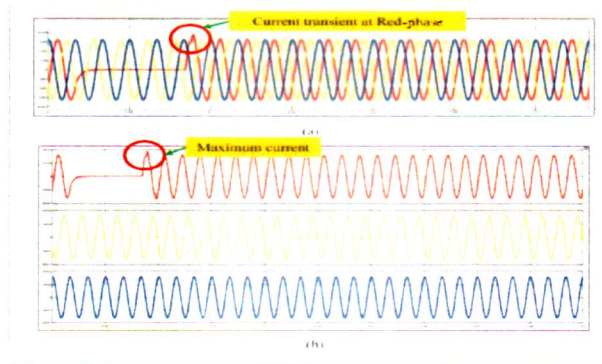
shows in Figure 7 shows an abnormal transient has occurred at the Red -phase while Yellow – phase and Blue - phase shows the normal wave.

FIGURE 7. (a) Output current (b) R - Y - B output current voltage L-G fault L - G fault

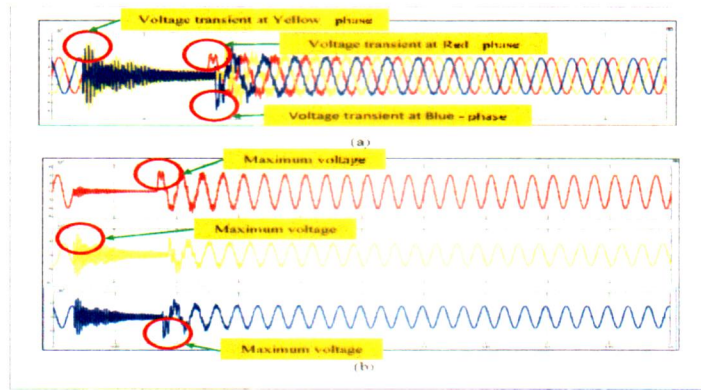
FIGURE 10. (a) Output voltage (b) R – Y – B output

Figure 10 shows the voltages in all lines are diminished to zero. Then, at the time of fault clearance, the voltage is increased tremendously for Yellow – phase line with a value of 774.9 kV with increment exceed at 100% as shown in Table 7. This can cause damage to transmission lines. In addition, Red – phase also produced the maximum peak

value of voltage at the fault clearance with a value of 529.0 kV at 0.105 with increment exceed 49.69 % while the Blue – phase signal generated a maximum peak value of voltage with a value of 701.4 kV at 0.020 s with increment 98.47% as shown in Table 7.

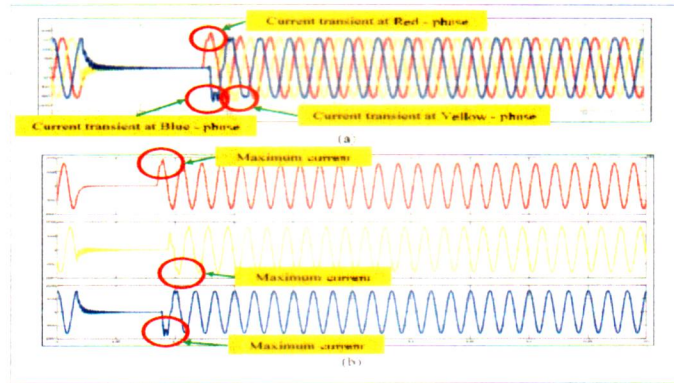
FIGURE 11. (a) Output current (b) R – Y – B output current 3L - G fault.current 3L - G fault.

Figure 11 shows the output waveform of the current at the receiving – end of the EHV long-distance transmission line model. The current in all the three lines

is reduced to zero after the fault occurred and increased the values after clearance of the fault (Chukwuekwe, D. O.et al. 2023). The Red – phase signals have the maximum

peak value of current 1895.0 A at 0.090 s with increment 16.04 % as in Table 8. Table 8 presented a Yellow – phase signal and the Blue – phase signal produced a maximum peak value of current with a value 1703.0 A at time 0.111 s with increment 4.29 % and 1645.0 A at 0.200 s with increment 0.74 %, respectively. Meanwhile, for the Red – phase signals the maximum value of current was 1853.0 A for Red – phase signals.

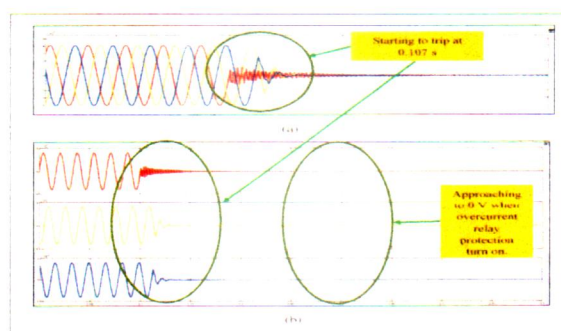
FIGURE 13. (a) Output voltage (b) R – Y – B output voltage L - G fault.

Figure 13 shows the voltage waveform after IDMT O/C relay protection is applied when L – G fault occurred. The waveform for the R – G will be tripped at 0.107 s and

approaching zero. The Y – G and B – G lines also started approaching zero as it reaches 0.107 s as the system will trip as there is over-voltage occur in the system.

The IDMT O/C relay protection when the L -G fault occurred with the trip signal. The trip started at 0.107 s. The IDMT O/C relay is activated when it detects the overcurrent flow in the transmission line model.

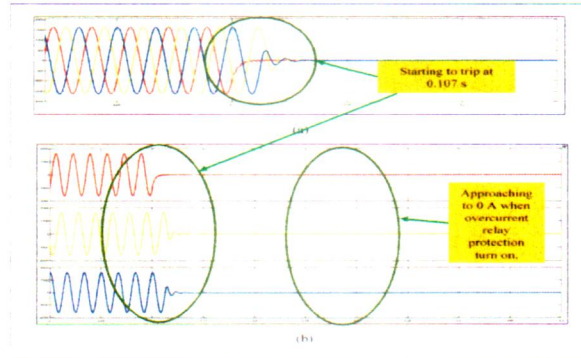
FIGURE 14. (a) Output current (b) R – Y – B output current L - G fault.

Figure 14 shows the current waveform after IDMT O/C relay protection was applied. The waveform for the R – G will be tripped at 0.107 s as the overcurrent occurs at R – G and then continue approaching zero. The Y – G and B – G lines also started approaching zero as it reaches 0.107 s as the system will trip when the overcurrent occurred in the system.

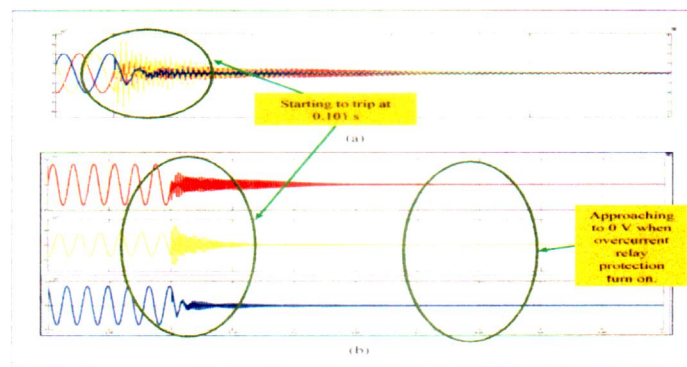
FIGURE 15. (a) Output voltage (b) R – Y – B output voltage LL - G fault

Figure 15 shows the output voltage waveform after IDMT O/C relay protection tripped at 0.107 s as the overvoltage occurs at R – G and Y – G lines when it reaches

0.101 s. The B – G line also started approaching zero as it reaches 0.101 s but slight delay as at B – G line is not experienced voltage.
