Stability of Rock Slope Using Kinematic Analysis: A Case Study at Bukit Gemilang, Sungai Besi, Kuala Lumpur (Paper 1)

ABSTRACT

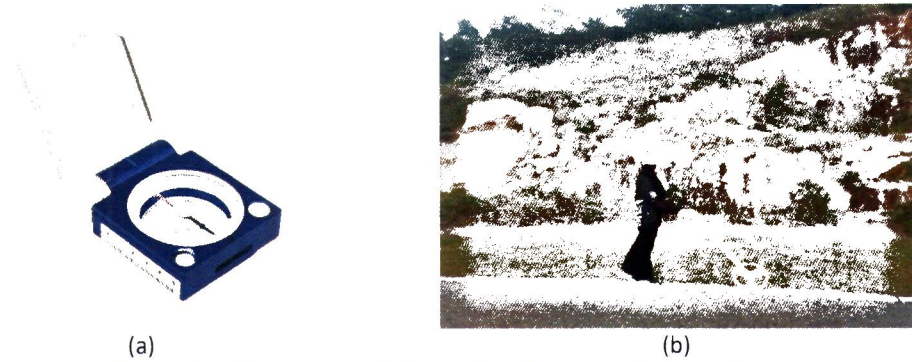
Fig. 2. (a) Breithaupt Geological Compass (b) Measuring distance using walking measure tape

The DD and DA data were obtained from geological compass that measured directly on the rock surface. This study used Breithaupt Compass with specification of ± 0.1 -degree accuracy for angle measurements in the horizontal and vertical planes as shown in Fig 2(a). The distance of each

discontinuity is collected using distance meter tape for manual mapping (see Fig 2(b)). A total of 110 measurements of discontinuities directions and orientations were measured and analyzed.

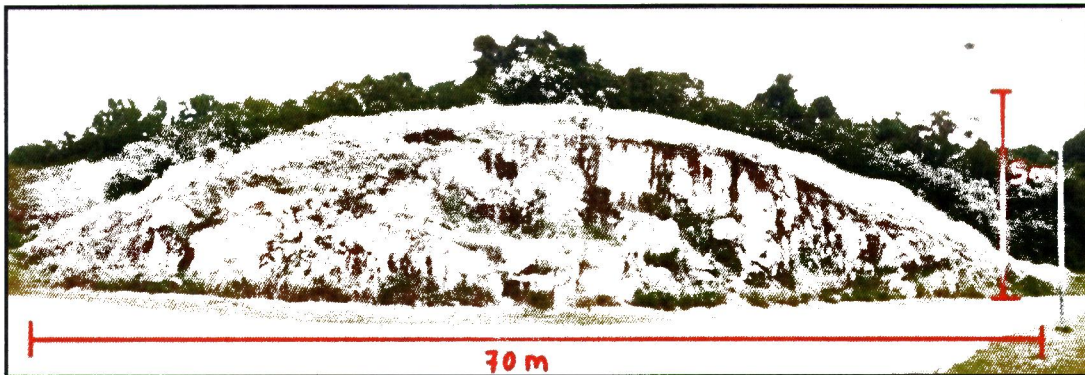
Fig. 3. Width and height of the selected section of Bukit Gemilang outcrop

The selection of specific rock slope section for stability analysis is determined based on weathering condition and critical joint set exist in the rock mass [15]. Fig 3 shows the selected slope section with width and height of 70m and 5m. Fig 4 shows the DA and DD readings obtained by using compass and the results tabulated in Table 1.

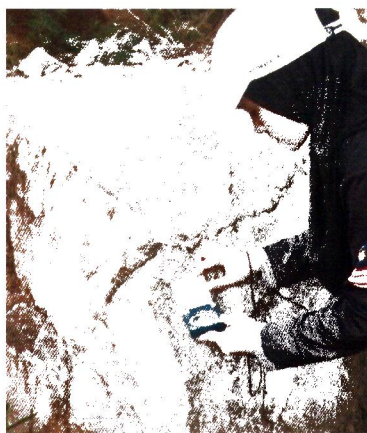
Fig. 4. Discontinuities data collection by using compass

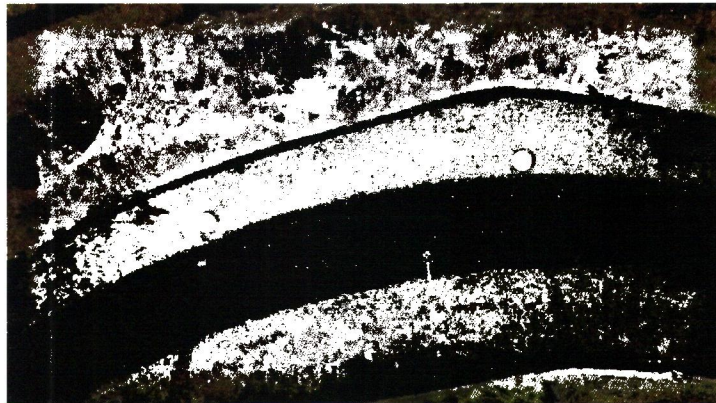
Fig. 5. Selected points for TLS setups from plan view

TLS is able to collect and scan almost two million points per second High-Dynamic Range (HDR) picture, in less than three minutes. This equipment is used to extract DA data from point clouds through Cyclone FIELD 360 software, which can be viewed using Leica TruView Cloud [16-18]. Fig 5 shows the study involves setting up a TLS setup in front of a rock slope section as indicated by red color, scanning the 360-degree section, and collecting data at three points. The data is then imported into Cyclone FIELD 360 software and integrated with GNSS. The DA data were measured through Leica TruView software by selecting 2 points on rock surface to generate angle measurement as shown in Fig 6.

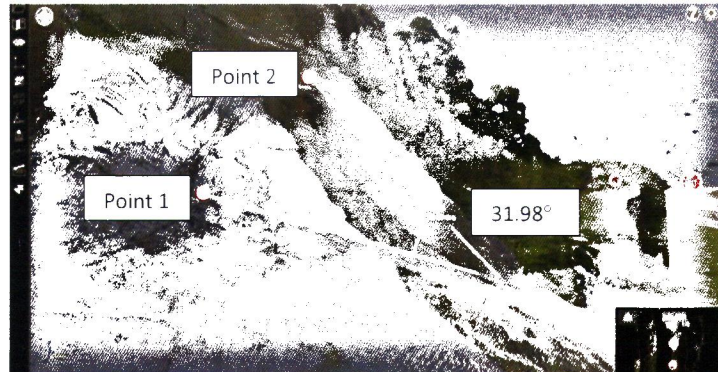
Fig. 6. Example of dip angle measurement through Truview Application.

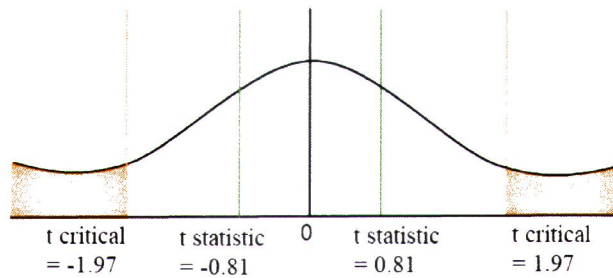
Fig. 7. Schematic drawing of t-test result distribution

The p-value for two tail analysis is 0.42 which is larger than 0.05 thus implies that there is no significant difference between data collected through conventional and TLS method. Fig 7 shows the test should fail to reject the Ho since the t-statistic value is not in the rejection region. The results proved that conventional and TLS yielded similar values and the difference is not significant, which indicates the accuracy of data collected from both methods are acceptable.

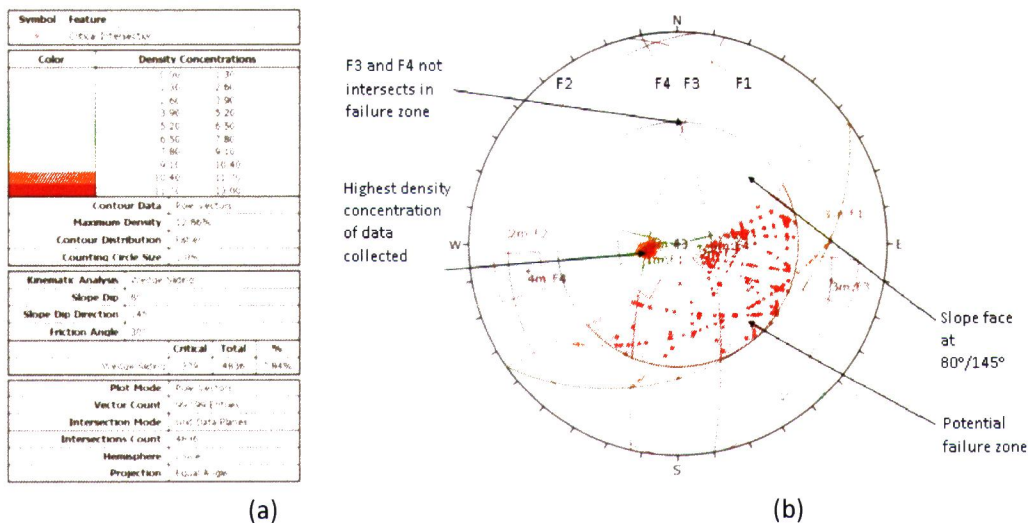
Fig. 10. Contour plot of poles to discontinuities (a) Density concentration (b) Wedge sliding analysis

Fig 10 shows the discontinuities contour plot of Bukit Gemilang for wedge failure analysis. The pink area indicates the potential of wedge failure region in normal slope. The result shows that there are no two joint sets had intersected each other, except for F3 and F4. The discontinuity joint F3 plane $74^\circ/103^\circ$ intersecting the discontinuities joint F4 plane $72^\circ/260^\circ$, however it does not lean on the potential failure zone. Therefore, the possibility of wedge failure can occur at the Bukit Gemilang slope is considered low with percentage value 7.84%. Fig 11 (a) shows the potential location of wedge planar failure identified at site within chainage 35m to 45m. Fig 11(b) shows the schematic drawing of how the wedge failure can occur if F3 and F4 joint set intersect each other and the direction is parallel with slope direction [20].

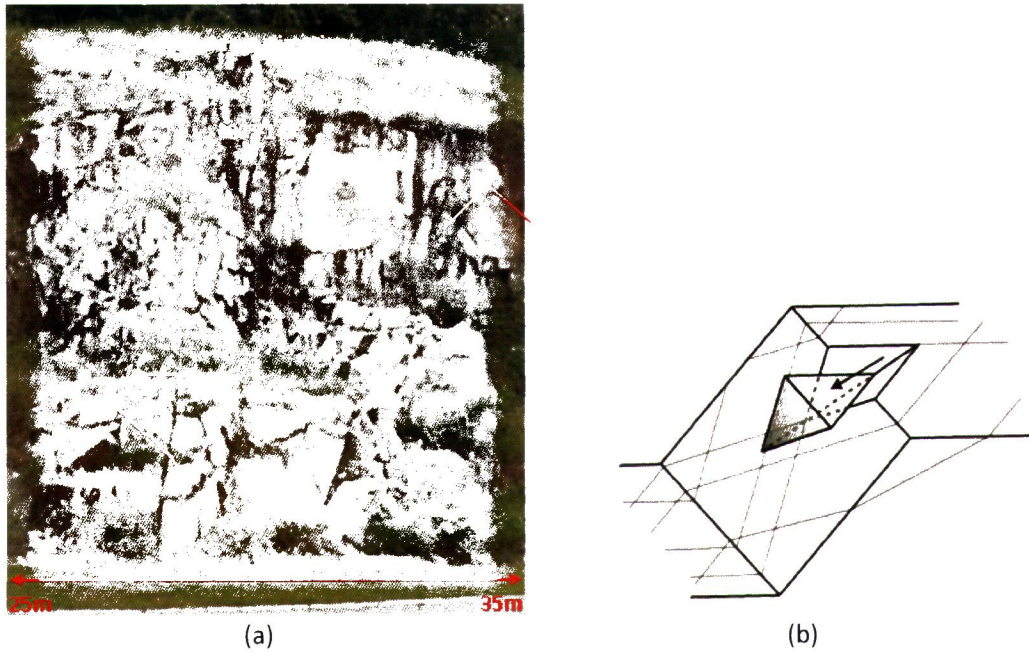
Fig. 11. (a) Location of wedge failure on Bukit Gemilang outcrop (b) Schematic illustration of wedge failure

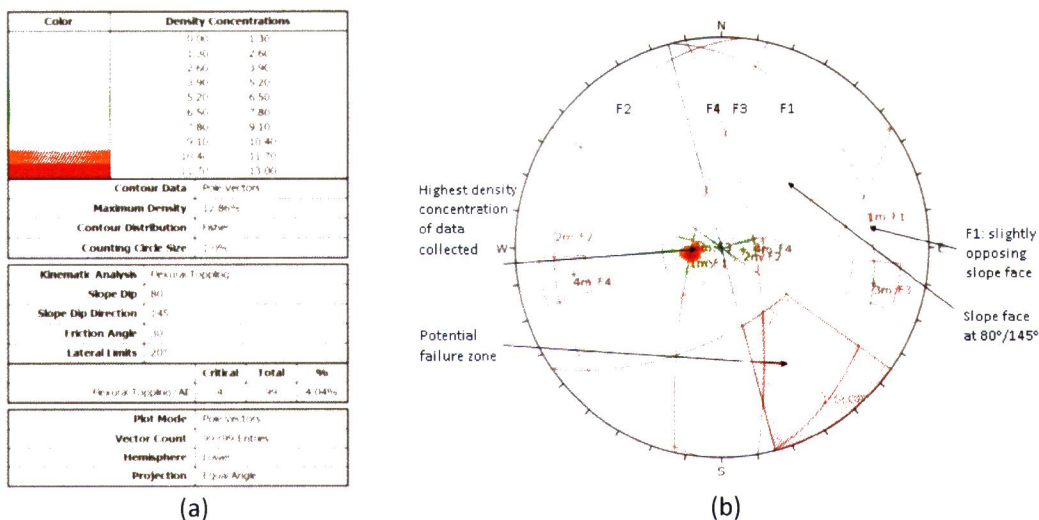
Fig. 13. Contour plot of poles to discontinuities (a) Density concentration (b) Toppling sliding analysis

Fig 12 shows the contour plot of discontinuities plane of Bukit Gemilang for toppling failure analysis. Based on this research, three out of four discontinuity planes which are F2 $12^\circ/96^\circ$, F3 $74^\circ/103^\circ$ and F4 $72^\circ/260^\circ$ were not opposed to the slope face direction $80^\circ/145^\circ$. However, F1 $18^\circ/256^\circ$ very slightly opposes the slope face direction. The analysis shows that a very low possibility of toppling failure can occur at Bukit Gemilang with a percentage value of 4.04%. Fig 13 (a) potential location of toppling failure identified at site within chainage 15m to 20m. Fig 13 (b) shows schematic drawing of the potential toppling failure can occur [21].

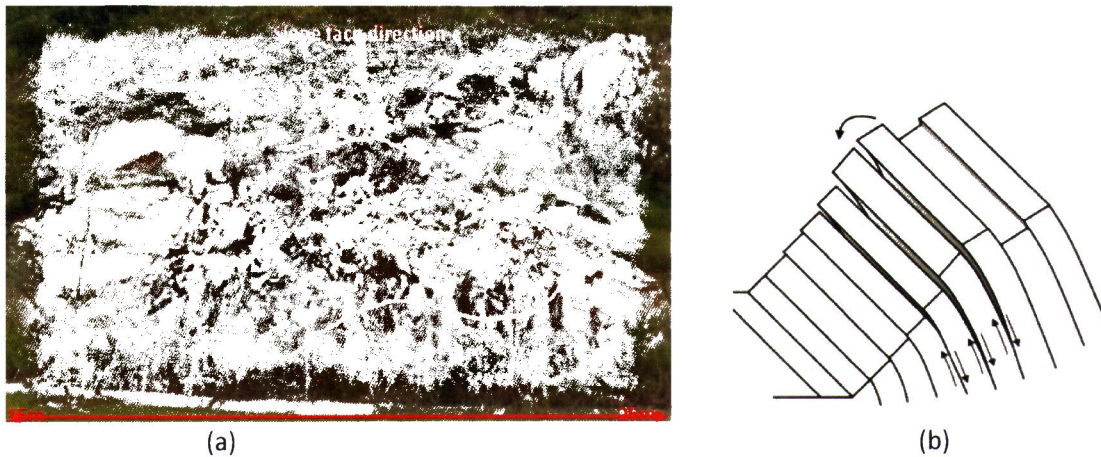
Fig. 14. (a) Location of toppling failure on Bukit Gemilang outcrop (b) Schematic illustration of toppling failure
