GEOTECHNICAL INVESTIGATION OF A LANDSLIDE INCIDENT IN HULU KELANG, MALAYSIA

Jestin Jelani¹, Muhammad Shafiq Soffian Abdul Rahman¹, Suriyadi Sojipto¹, Wan Mohamed Syafuan Wan
Mohamed Sabri¹, Lee Min Lee² and Nordila Ahmad¹

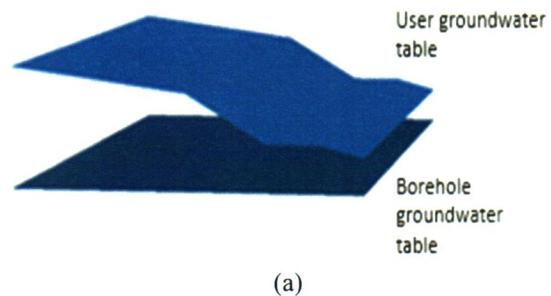
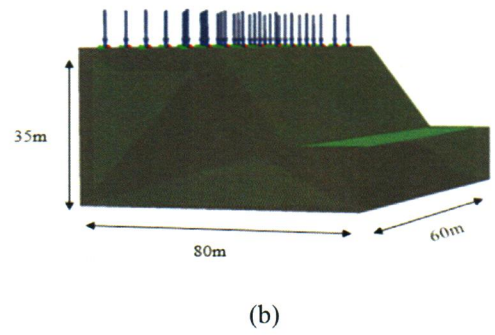
Fig.6 The slope model in Plaxis 3D. (a) Groundwater table input. (b) Slope dimension.

This research used a finite element analysis method (FEM), the Plaxis-3D software, to evaluate slope stability and analyse the mode of failure. Figure 6a shows the two levels of the groundwater table for the flow condition stage, where the lower level is a borehole water table located at a depth of 25m from the ground surface, and the upper level is the user-defined water table located approximately 4m based on the site investigation conducted by local experts. Figure 6b shows the 3D model of the slope in Plaxis 3D with a height, width and length of 35, 60m, and 80m, forming a 35° slope angle. A 50kN/m² surcharge load was imposed at the top of the slope to represent the structural load from existing buildings.

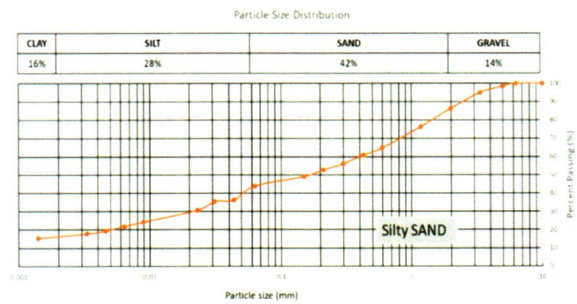
Fig.9 Particle size distribution

Figure 9 shows the result of the sieve analysis. The soil consists of 16% clay, 28% silt, 42% sand and 14% gravel and, thus, classified as silty SAND based on British Standard soil classification. The Liquid Limit and Plastic Limit for the soil is 40 % and 26 %, thus classifying the soil as low plasticity.

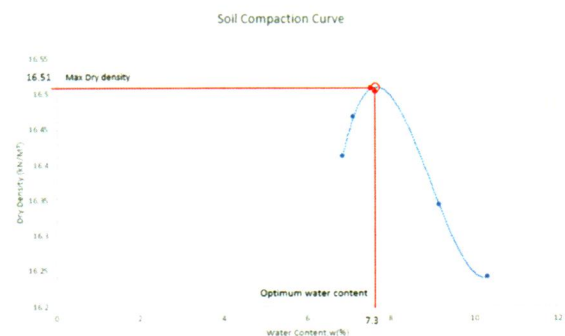
Fig.10 Soil compaction.

Figure 10 shows the result of the soil compaction test, where the maximum dry density of the soil is 16.51 kg/m^3 at an optimum moisture content of 7.3%.

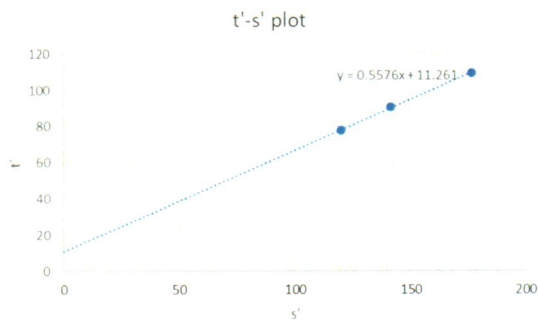
Fig.11 The shear strength parameters derived from t'-s' plot.

The CU triaxial compression tests were conducted at three confining pressures of 50kPa, 100kPa and 200kPa for specimens A, B and C. Figure 11 shows the test result for the shear strength of the soil, where the cohesion, c , and angle of internal friction, ϕ , were 11.3 kN/m^2 and 29° .

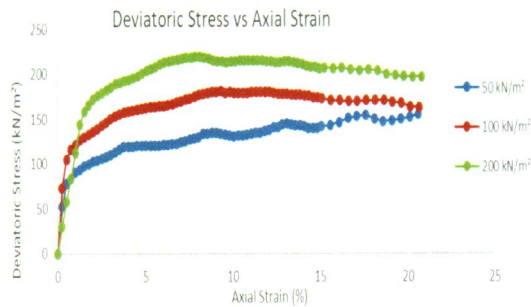
Fig.12 Stress-strain curve

The soil stiffness parameter, E_{50} , was determined from the slope gradient of the stress-strain curve of each sample (see Figure 12). The average of the slope gradients was E_{50}^{ref} . The E_{ode}^{ref} and E_{ur}^{ref} were calculated using Eq. 1 and Eq. 2. Table 2 summarises the input strength parameters for the Hardening Soil Model (HSM) obtained from CU triaxial compression results.
