1. Introduction

The aim of this study is to investigate the behavior of steel plate protected with gypsum board subjected to explosion and fire through experiment. Nines square 3 mm thickness mild steel plates S275 which is 500 mm x 500 mm in dimensions will be subjected to explosion. The exposed area is 300mm x 300mm. The gypsum board used is from brand USG BORAL Impactstop, impact resistant board with 19mm thickness as shown in Figure 1. The explosive used is Plastic Explosive (PE4).

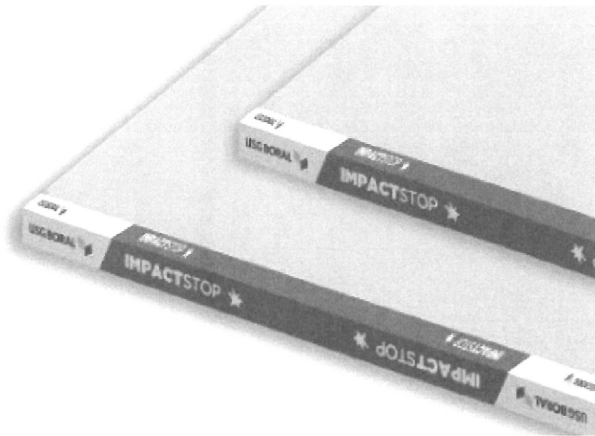
Figure 1: USG BORAL Impactstop gypsum board

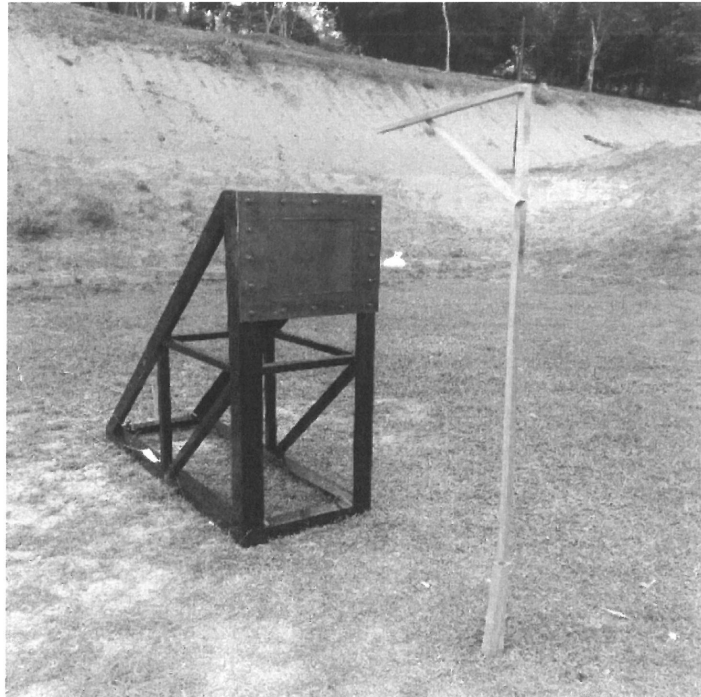
Figure 2 shows the setup for the explosion test. It consists of a test jig made from steel angle section; the test plate is placed at it face position and fixed with clamp plate at 1.5 m height. The exposed area of the plate is 300 mm x 300 mm. One PE4 charges are used in the explosion tests which is 100g for each cases. The minimum amount of charges chosen was to make sure the charges will not totally damage the steel plates or gypsum boards, however it is able to make small deflection to the steel plates. The stand-off distance is 1 m from the center of the steel plate. Three cases are analyzed in the present study: Case 1- steel plate only, Case 2 - steel plate with gypsum board and Case 3 - steel plate with gap and gypsum board. The gap distance is 19 mm. Example of the case 3 is shown in Figure

Figure 2: Experimental setup for explosion test Case 1 –Steel Plate only

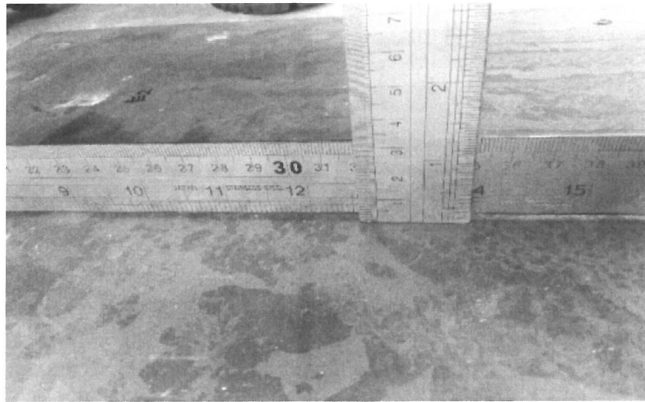
Figure 7: Deflection of steel plate + gypsum

from position resulted from explosion test as shown in Figure 5. Therefore, direct measurement is taken to measure final deflection of the steel plate. Even though this technique will not give accurate result, still it can give some overview on the data available. The deflection of each cases can be seen in Figure 6 to Figure 8.

Table 1 shows the final deflection of steel plate for each cases. As can be seen, the deflection decreased when the steel plate was protected with gypsum board. The deflection was further reduced when there is gap between the steel plate and gypsum boards. The results indicate that the board type of fire protection system do have some energy absorption capacity to reduce the effect of explosion to the structures.
