## **INTERFACE SHEAR STRENGTH AND THE SOIL SOFTENING EFFECT ON THE SOIL-GEOCOMPOSITE DRAINAGE LAYER SYSTEM STABILITY**

### **Abstract**

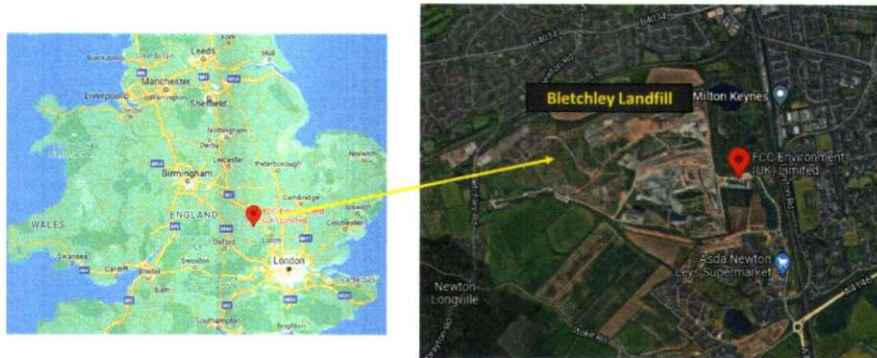
**Fig. 1 Bletchley landfill, Milton Keynes, UK trial site [23].**

The landfill cover/capping system was constructed in autumn 2011 as a field experimental capping system at Bletchley landfill, Milton Keynes, UK (Fig. 1) by [23]. Fig. 2 shows the field trial of landfill cover at landfill site. In this research, the field measurement works is measured on the same field site panel. Currently, the Bletchley landfill site is actively operational, but the study was conducted on the new trial capping system on the closed landfill cell.

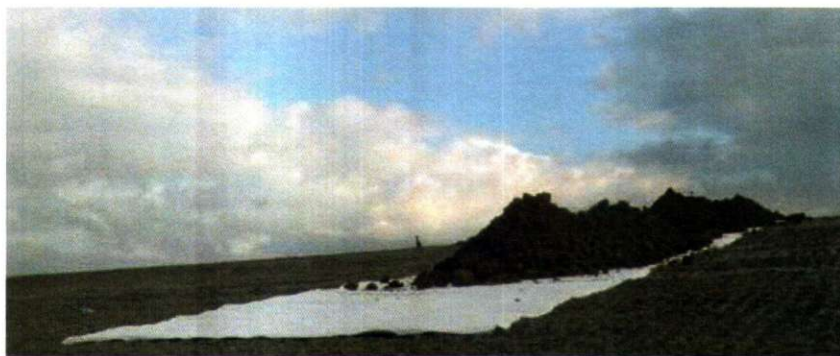
**Fig. 2 Bletchley landfill trial site [23].**

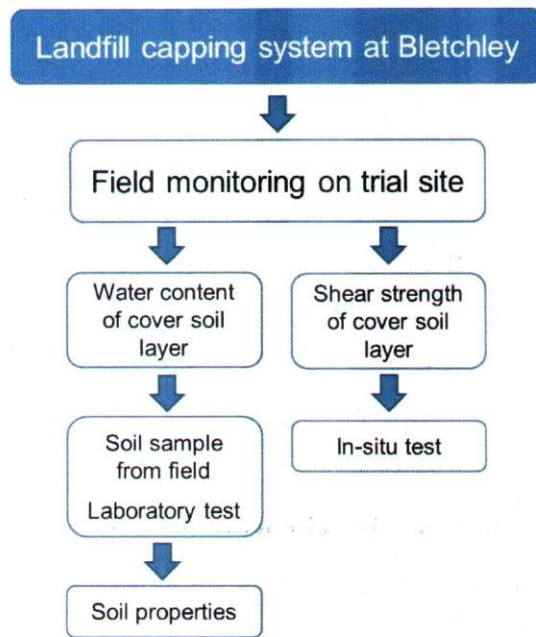
**Fig. 3** The primary phases of field work at Bletchley landfill cover trial site.

The primary objective on the fieldwork is to examine the landfill cover system stability using different forms of geosynthetic drains. The field work stages are shown in Fig. 3. The fieldwork is to examine the effects of soil water/moisture content on the interface shear strength of soil-GD layer.

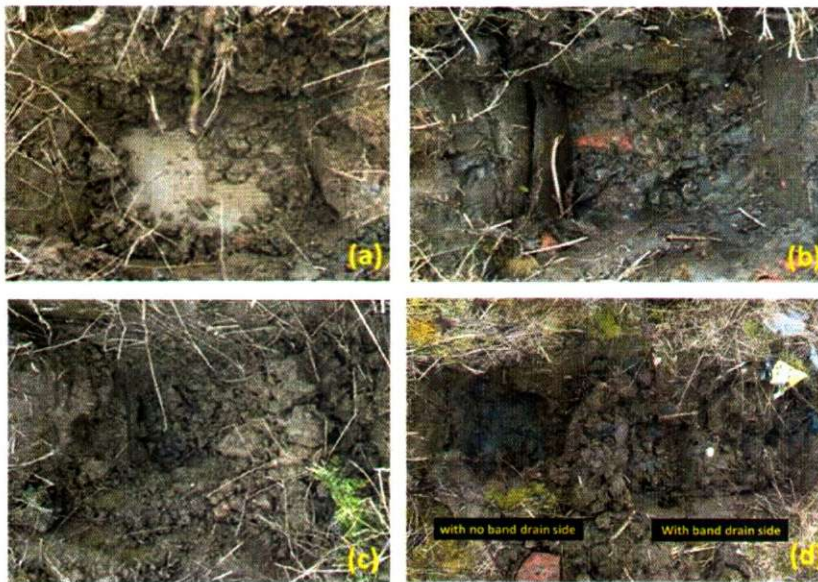
**Fig. 4** (a) Panel 1- cusped core GD, (b) Panel 2 (Control panel) - without any geosynthetic drain, (c) Panel 3- non-woven needle punched geotextile GD and (d) Panel 4- GD with band drains and with no band drain side.

The capability of four different types of GD is being tested on the field testing. In this field site, Panel 1 was installed with the geocomposite drain with cusped core, while Panel 2 is a panel with no geosynthetic drain i.e. control panel, Panel 3 was layered with a non-woven needle punched geotextile sandwiched GD and lastly, Panel 4 was installed using the GD with band drains. Furthermore, Panel 4 features two separate GD sides, one of which had a band drain and the other without any band drain. Fig. 4 shows the different types of GD installed. The size of the trial landfill cover panel was 40 x 6 m (length and wide) with a slope inclination of 7.2° (1v:8h) in average.

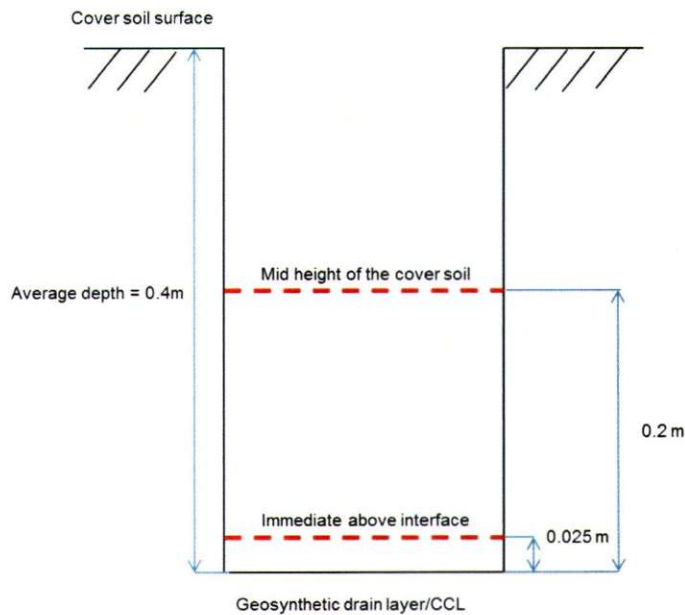
**Fig. 4** The soil sampling location on the cover soil layer above geosynthetic drains/CCL panel.

The relationship between soil moisture content and the shear strength of soil-GD layer interface influences the stability performance of landfill cover application. The sampling are samples at two different heights includes at the position of mid height of the cover soil (0.2 m from the interface) and immediate above interface (0.025 m from the interface) as shown in Fig. 4. In total of 32 samplings of soil were obtained from the trial cover site. The testing on the amount of water in the cover soil above each geosynthetic drain installed was carried out in the laboratory using the soil sampling from the trial set.

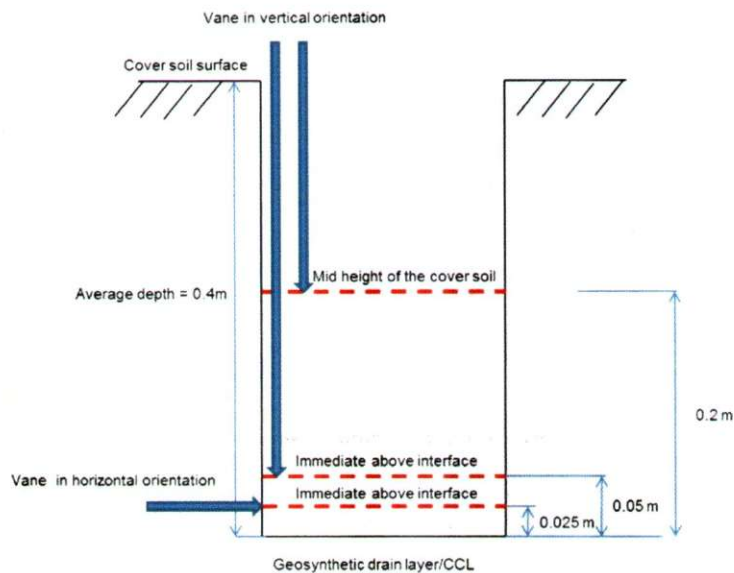
**Fig. 5 The measurement of in-situ shear strength on the landfill cover soil layer above geosynthetic drains/CCL position, in both orientations (vertical and horizontal).**

In this field measurement, a mobile type of shear vane apparatus has been applied to assess the in-situ shear strength of the landfill cover soil. The

measurement was taken using horizontal and vertical orientation of vane as shown in Fig. 5.

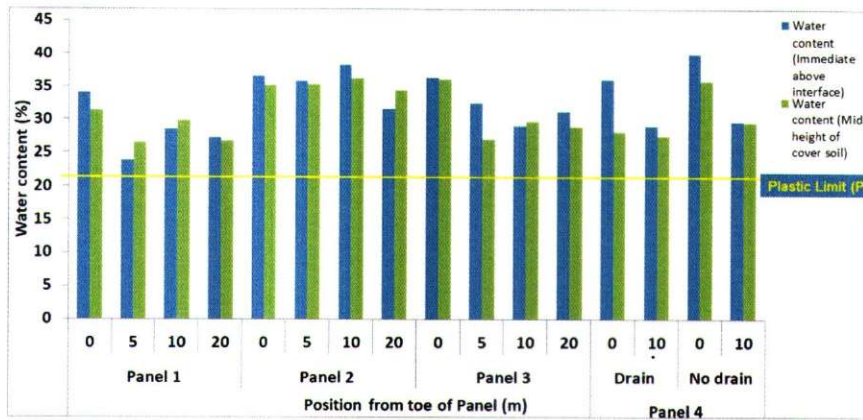
**Fig. 6** Soil water content measurements above geosynthetic drain at different position from toe of the panel for Panel 1, 2, 3 and 4 at Bletchley landfill trial site.

The soil properties of soil samples collected at Bletchley landfill cover site were investigated in the soil laboratory. Based on the Casagrande plasticity chart [24], the specimens resulted to be plasticity clay (CI). The index properties are Liquid Limit (LL) = 50% and Plastic Limit (PL) = 21%. The measured value of landfill cover soil water content is reported in Fig. 6. The highest value was measured at the toe of panel (0 m from toe) where the soil layer at immediate above interface. These values were consistent at all panel. In average, Panel 2 consists of higher water content at both positions compared to other panel with an average of 38%. The percentage of water content at control panel also shows higher compared with panel with drain at Panel 4. Furthermore, water content at the interface of soil-geosynthetics shows an increment along the panel. The water content tends to increase to 30% where exceed the value of Plastic Limit (21%) of the soil. The results are consistent in all panels. This conditions also agreed by [19, 20].

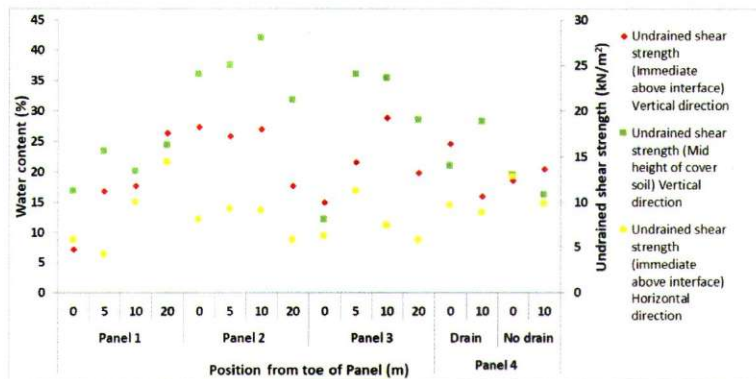
**Fig. 7** Undrained shear strength measurements at different position using vertical direction and horizontal direction above geosynthetic drain for Panel 1, 2, 3 and 4 at Bletchley trial panel.

Fig. 7 shows the observed result of in-situ shear strength on the landfill cover soil at the different position of above the layer of geosynthetic drains/CCL. Based on the results shows that majority of the lowest shear strength consistently shows at immediate above interface of soil-geosynthetics with horizontal direction of testing with average of 8.6 kPa. The highest undrained shear strength measured mostly around area mid-height of cover soil, further higher of interface with an average of 18 kPa using vertical direction of measurement. The measurement obtained near the toe position always low compared to the further higher position from toe for all panel. The shear strength of cover soil shows to decrease around 50% especially at Panel 1 and this may have related to water accumulation in a cover soil at the same panel. In average, Panel 1 hold the lowest shear strength.
